# **Intel<sup>®</sup> Mobile Pentium<sup>®</sup> II Processor Specification Update**

Release Date: August 2000

Order Number: 243887-023

The Mobile Pentium<sup>®</sup> II processor may contain design defects or errors known as errata which may cause the product to deviate from published specifications. Current characterized errata are documented in this Specification Update.

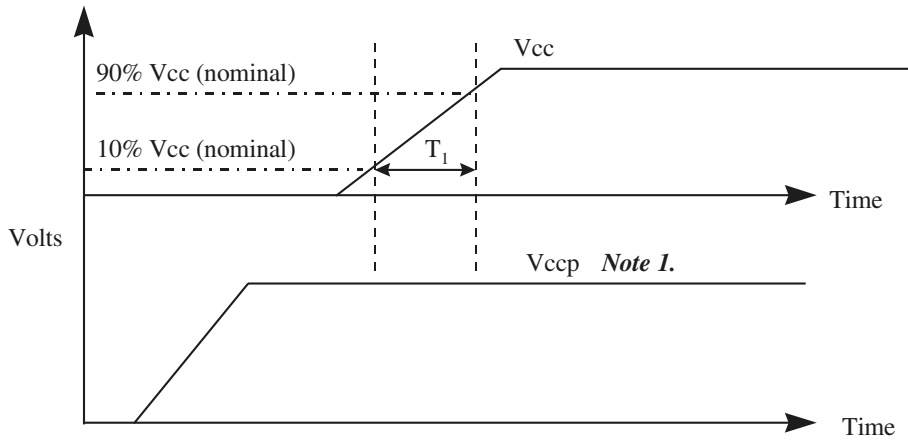
**Figure 1. V<sub>CC</sub>/V<sub>CCP</sub> Timing Requirements (Mobile)**

**Problem:** The processor uses the PWRGOOD signal to ensure that no voltage sequencing issues arise; no pin assertions should cause the processor to change its behavior until this signal is asserted, when all power supplies and clocks to the processor are valid and stable. However, if  $V_{CC}$  ramps up before  $V_{CCP}$ , it will cause the processor to enter an invalid state.

**Implication:** If this erratum occurs, the system may boot normally however, the L2 cache may not be initialized.

**Workaround:** For Mobile Pentium II processors, ensure that  $V_{CC}$  ramps after or with the L2 cache IO voltage ( $V_{CCP}$ ). If  $V_{CCP}$  ramps after the  $V_{CC}$ , a delay circuit can be placed on the core  $V_{CC}$  to ensure that  $V_{CC}$  ramps at the same time or after  $V_{CCP}$  as shown below in Figure 1.

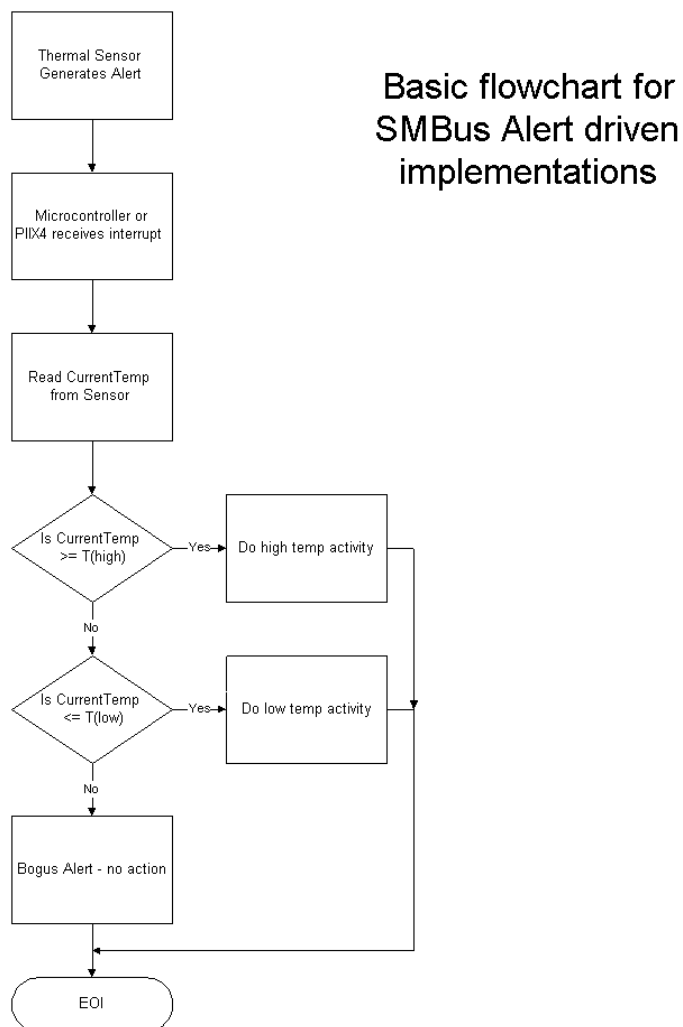
Figure 2. Workaround Flowchart: SMBALERT#-Driven System

### B30. Thermal Sensor May Assert SMBALERT# Incorrectly

Under the conditions described below, the thermal sensor incorrectly generates the SMBALERT# interrupt. All of the following conditions must be met to trigger a false interrupt:

1. Before servicing an interrupt from the thermal sensor, read and compare the processor thermal reading with the threshold limits ( $T_{HIGH}$  or  $T_{LOW}$ ). Figures 2 and 3 provide basic flowcharts for the implementation of this workaround in an interrupt driven system.
2. If the firmware implemented polls the Status Register only, then before taking any action, re-read the temperature register and do a comparison with the alarm threshold limits ( $T_{HIGH}$  or  $T_{LOW}$ ) to determine if the value is actually still within the temperature window.

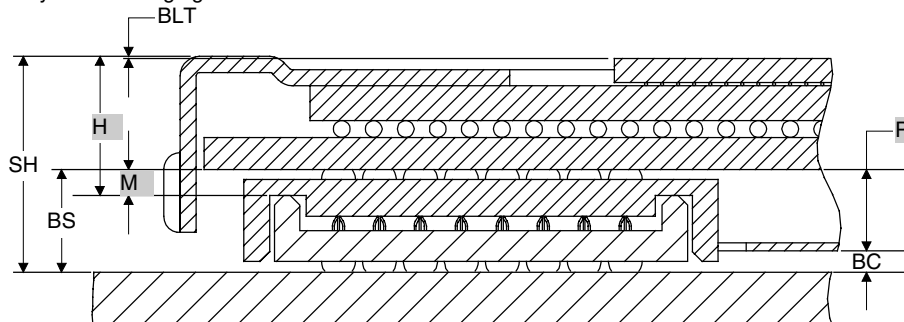
**Figure 5.6. Cross Sectional View with Vertical Dimensions**

### B1. Misabeled Vertical Dimension Parameters

Figure 5.6 in the *Mobile Pentium® II Processor at 233 MHz, 266 MHz, and 300 MHz* datasheet should be replaced by the following figure:

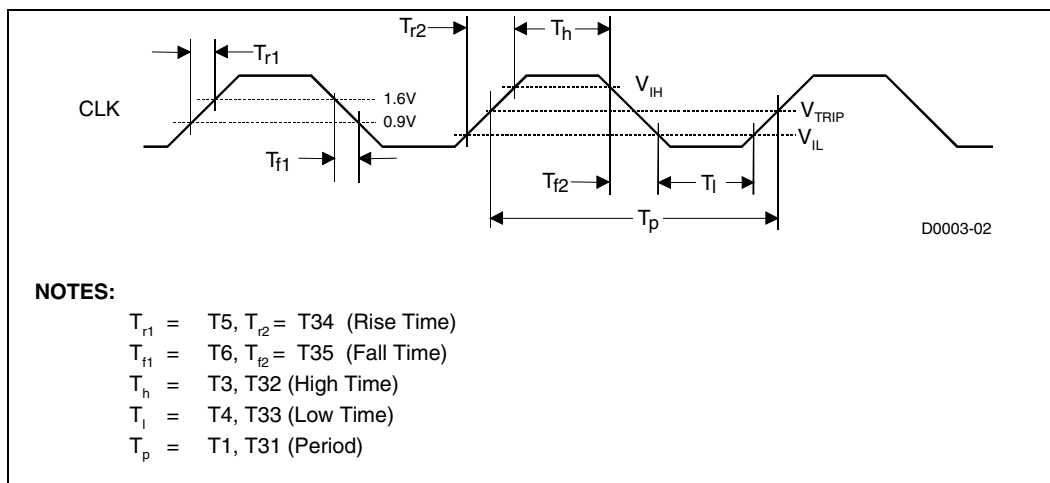
Figure 3.3 Generic Clock Waveform

### B14. Generic Clock Waveform Figure

Figure 3.3 in *Mobile Pentium® II Processor in Mini-Cartridge Package at 366 MHz, 333 MHz, 300PE MHz, and 266PE MHz* datasheet (Order Number 245108), and the *Mobile Pentium® II Processor in BGA Package at 366 MHz, 333 MHz, 300PE MHz, and 266PE MHz* datasheet (Order Number 245106) has been updated. The following figure is to replace the ones in the above documents.
